NASA
Technical
Paper
2032

July 1982

Buckling Test of
a 3-Meter-Diameter
Corrugated Graphite-Epoxy
Ring-Stiffened Cylinder

Randall C. Davis

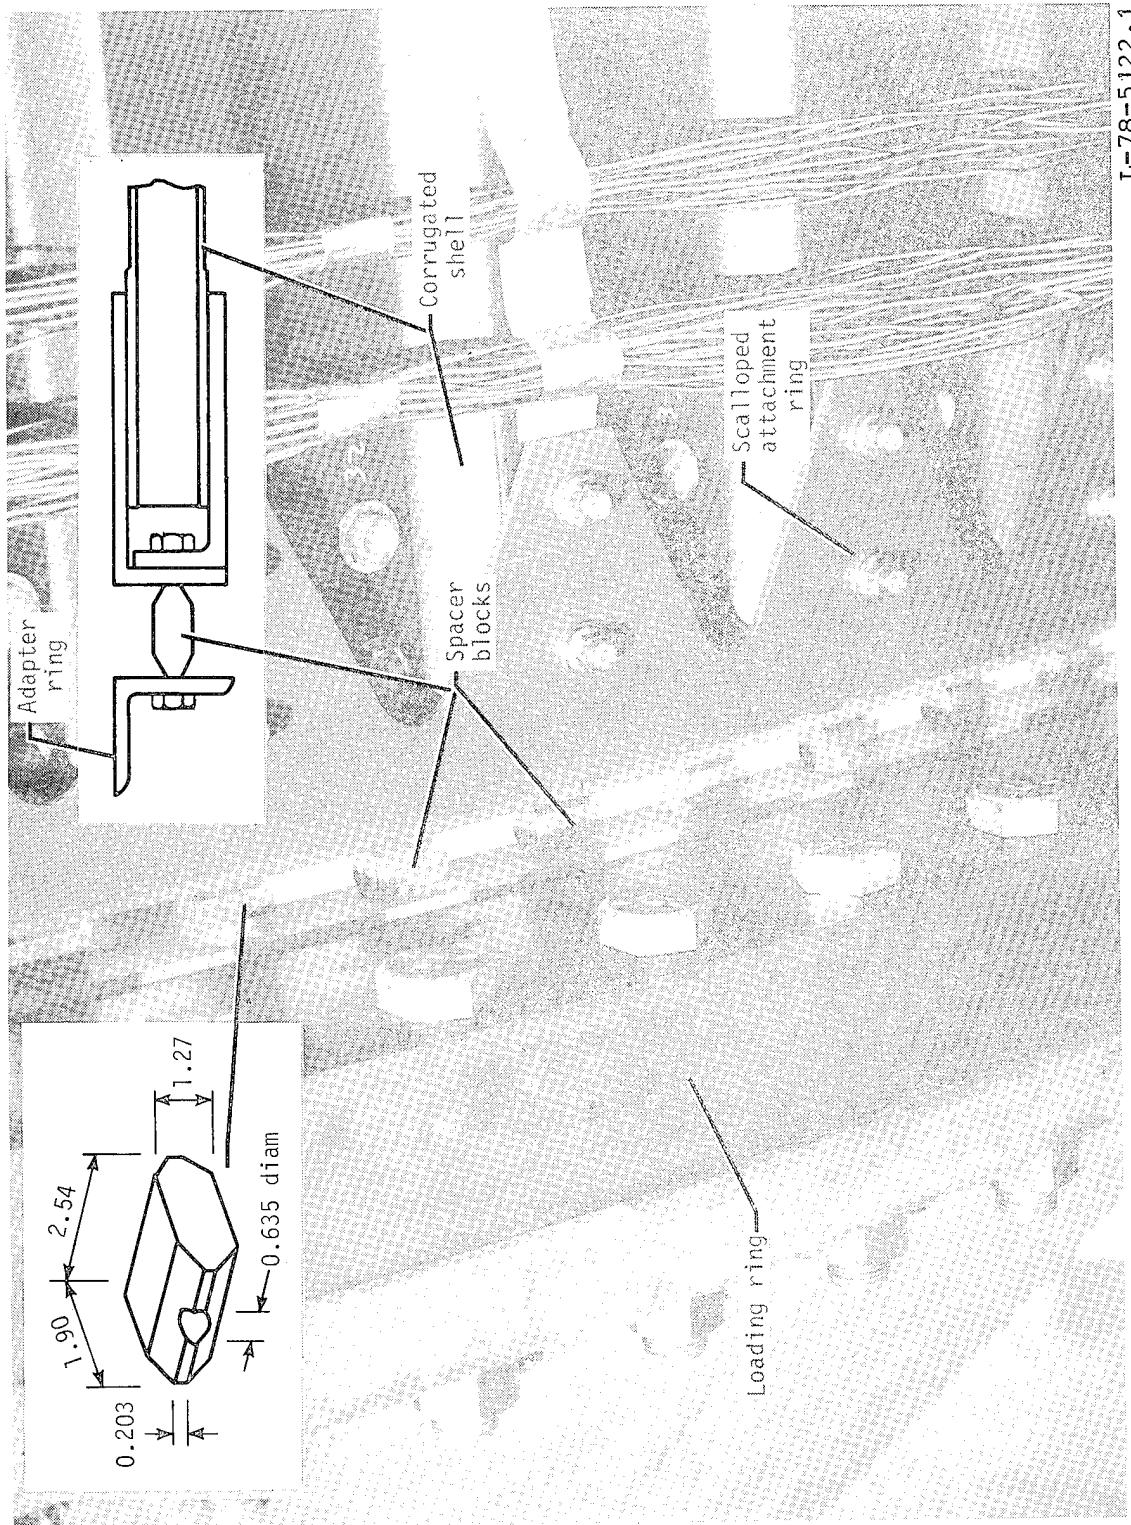
An examination of strain-gage data from a preliminary test of the cylinder at 30 percent of design load revealed a severe load introduction problem at the ends of the cylinder. A 5.56-cm offset between the centroid radius of the loading ring and the midsurface radius of the shell wall produced an inplane ring rolling moment in the loading rings that produced substantial shell-wall bending at the ends of the shell. The severity of the shell-wall bending caused concern over the possibility of premature buckling of the cylinder.

A second preliminary test made with the spacer blocks in place indicated that the bending strains in the shell wall were sufficiently reduced to allow a successful buckling test of the cylinder. No buckling or material failures were observed near the loaded ends of the shell during subsequent testing, indicating that the spacer blocks had sufficiently reduced the shell-wall bending strains to prevent a premature failure.

Figure 6.- Spacer blocks in place between scalloped attachment ring and adapter ring. Dimensions are in centimeters.

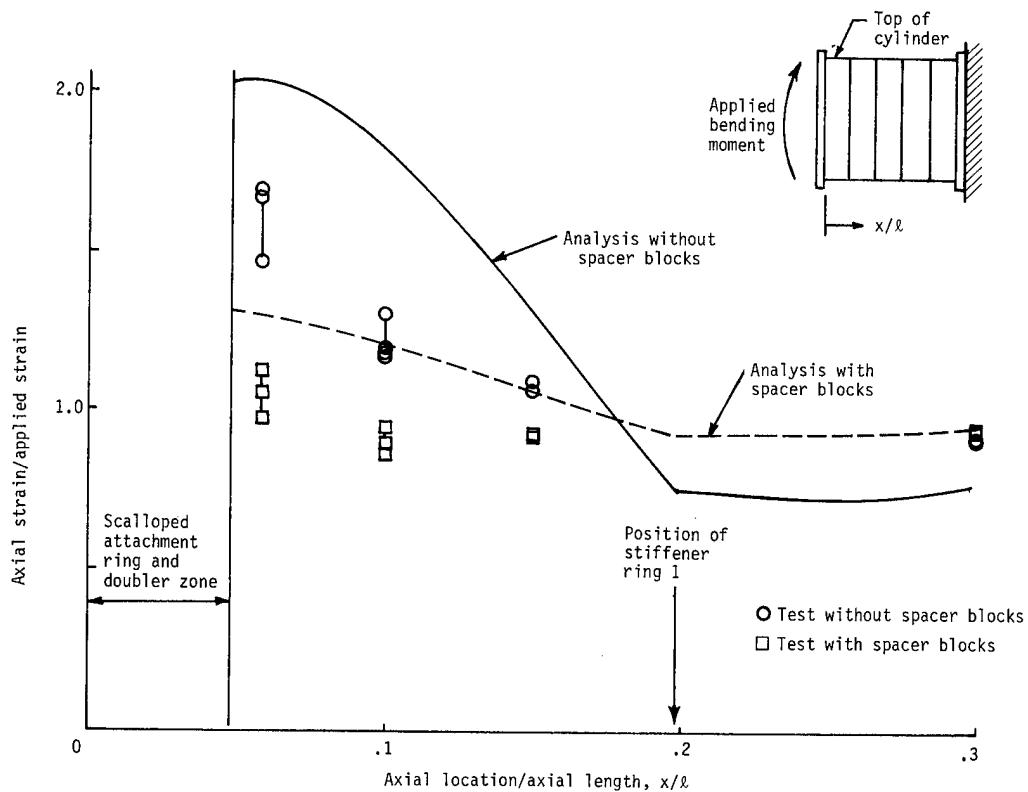
The experimental axial-strain distribution along the shell length is shown in figure 7, and the axial strains computed by the BOSOR 4 analysis is shown for comparison. These strain values have been normalized with respect to the applied axial strain as described in the preceding section. Although the absolute magnitudes do not compare exactly for experiment and analysis, the reduction trends between strains with and without the spacer blocks compare very favorably.

Figure 7.- Axial strain at top of cylinder from analysis and test at 30 percent of design load.
